## NATIONAL ENERGY BOARD REPORT

In the Matter of an Accident  
on 19 February 1985  
near Camrose, Alberta, on the Pipeline System  
of Interprovincial Pipe Line Limited

June 1986

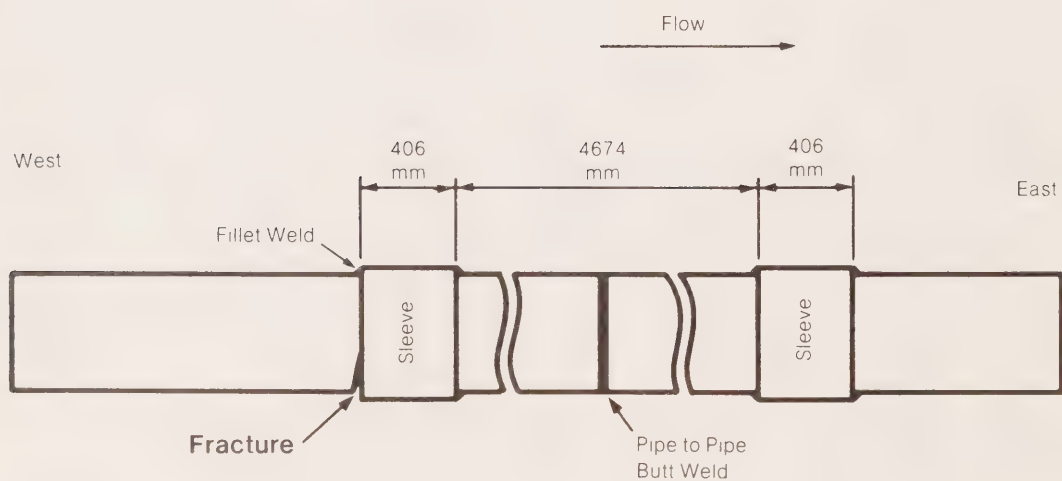
## Details of Pipe Section Examined for the Incident of 19 February 1985 at Kmp 84.12

On 19 February 1985, IPL's Line No. 1 suffered a break at KmP 84.12. The carrier pipe fractured adjacent to a full encirclement sleeve which had been installed on 26 July 1973 (see Appendix VI).

At the request of IPL, the Welding Institute of Canada carried out a metallurgical investigation of the Line No. 1 failure which occurred on 19 February 1985. Examination of the break revealed that Line No. 1 failed in the immediate vicinity of a full encirclement sleeve that had been welded to the carrier pipe. The fracture occurred along the toe of the sleeve to pipe fillet weld and was observed to have initiated at the bottom of the pipe at the six o'clock position (see Appendix VI).

Further examination revealed that the fracture originated from a crack, 483 mm in length, situated in the

heat affected zone (HAZ) associated with the sleeve fillet weld. The crack followed exactly every ripple of the fillet weld toe where it met the outside surface of the pipe. The crack had penetrated to a maximum 2.97 mm or 37 percent of the pipe wall thickness.

The crack in the weld HAZ was determined to have been caused by a hydrogen induced cracking mechanism. The metallurgical investigation determined that the crack had been formed at the time of the installation of the sleeve in 1973.

Final failure occurred due to the sudden propagation of the pre-existing crack, by brittle cleavage, when the level of longitudinal strain in the pipeline at the defect location exceeded a critical value. The strain required to produce defect propagation was estimated by calculation (Engineering Critical Assessment). It was shown that an applied axial strain of close to 0.2 percent would be necessary to initiate brittle fracture from the pre-existing crack. Since operating pressures were not sufficient to produce such axial strains, other mechanisms causing downward bending of the pipe, such as loss of ground support or frost heave, were likely responsible.

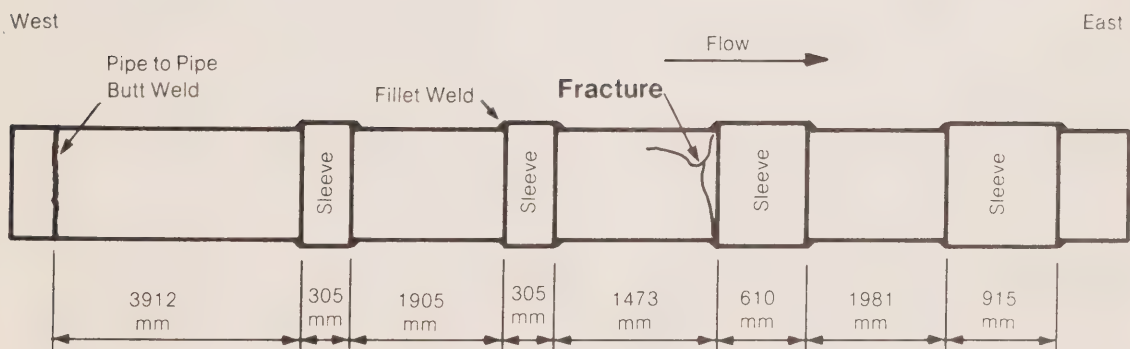
## Details of Pipe Section Examined for the Incident of 23 February 1983 at Kmp 82.3

On 23 February 1983, a pipeline break occurred on IPL Line No. 1 at KmP 82.3. In many respects, this break was similar to the one at KmP 84.12. The line suffered a complete circumferential fracture in the immediate vicinity of a full encirclement sleeve (see Appendix VII).

Following the 23 February 1983 break, a metallurgical failure investigation was carried out by the Welding Institute of Canada at the request of IPL. It was found that final failure occurred due to sudden propagation by brittle cleavage, of a pre-existing hydrogen crack. The defect was centred about the six o'clock position on the pipe, was approximately 210 mm in length and had penetrated to a maximum depth of 3.7 mm or about 46 percent of the wall thickness. There was some evidence of limited crack growth by metal fatigue prior to the final failure.

The microstructure of the fillet weld coarse grained HAZ, in which the hydrogen induced cracks had initiated, consisted entirely of martensite, a microstructure extremely sensitive to hydrogen induced crack formation.

Propagation of the pre-existing hydrogen crack and final failure occurred when either the crack grew slightly in service to a critical size or when the stress acting on the defect increased to a critical level. The latter may have been due to a change in service conditions, ground temperature or a loss of pipe support.

The sleeve at KmP 82.3 had been welded over numerous corrosion pits, the deepest having penetrated 3.20 mm or 40 percent of the wall thickness. Upstream of the failure location two additional 305 mm long sleeves were present within 4.0 m. A 915 mm long sleeve was present within 2.6 m downstream of the fracture. Thus within a distance of 6.6 m there were four sleeves.

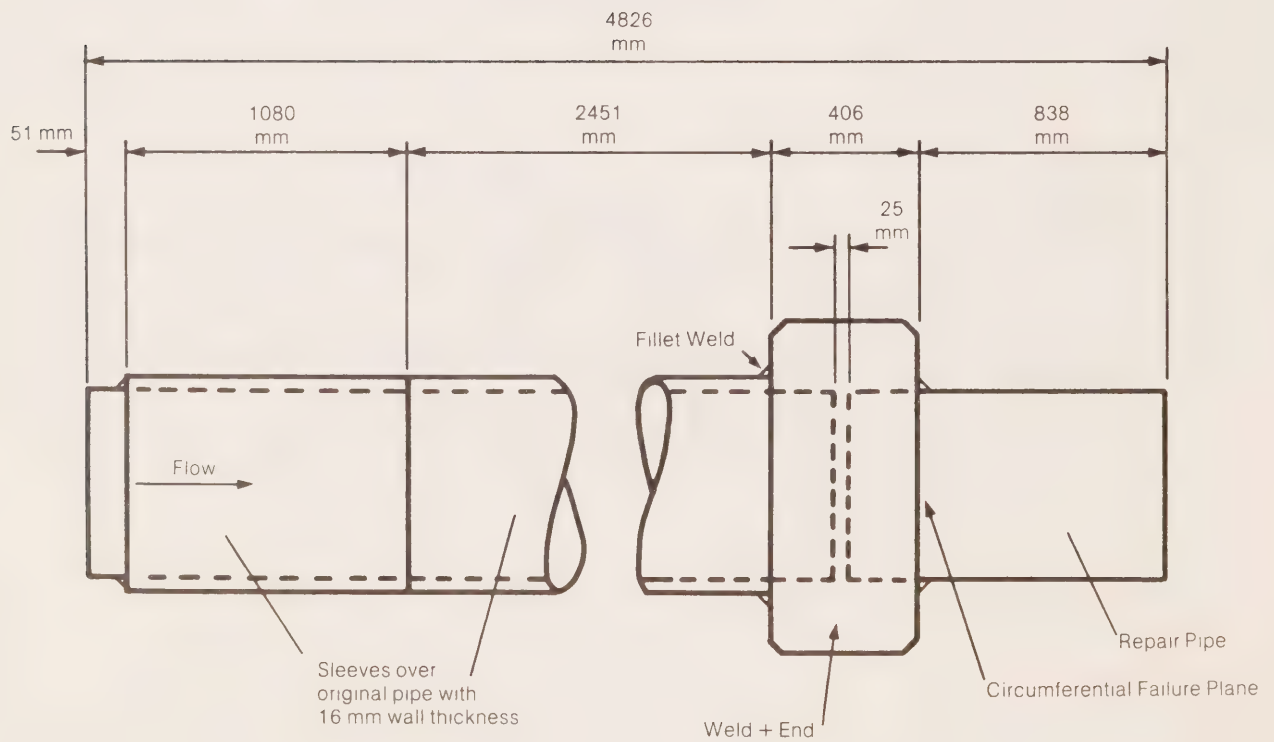
## Details of Pipe Section Examined for the Incident of 8 March 1976 at Kmp 121

On 8 March 1976, Line No. 3 fractured immediately downstream of one of the "weld + ends" couplings at KmP 121. The carrier pipe involved in the break, was the 6.1 m long repair pipe that had been installed in 1974. Immediately upstream of the coupling were two full encirclement sleeves covering a combined length of 3.53 m (see Appendix VIII).

Examination of the fracture showed that failure initiated at a pre-existing hydrogen induced crack, present along the fillet weld toe for almost the complete length of the fracture. The crack had penetrated up to 35 percent of the carrier pipe wall and was likely

formed soon after the fillet welds were made. The fracture was centred on the bottom of the pipe and had arrested at about the 9:30 and 2:30 o'clock positions. The HAZ of the final pass consisted of martensite and lower bainite, microstructures highly susceptible to hydrogen induced cracking.

Propagation of the pre-existing crack was likely caused by bending stresses resulting from poor bearing support beneath this particularly heavy section of pipeline located within a slough area.
